IN FOR A PENNY

John Dynes had to interrupt his retirement to fund this extensive and superb Mini 95 Pick-up build...

Modified 1980 Mini 95 Pick-up 850

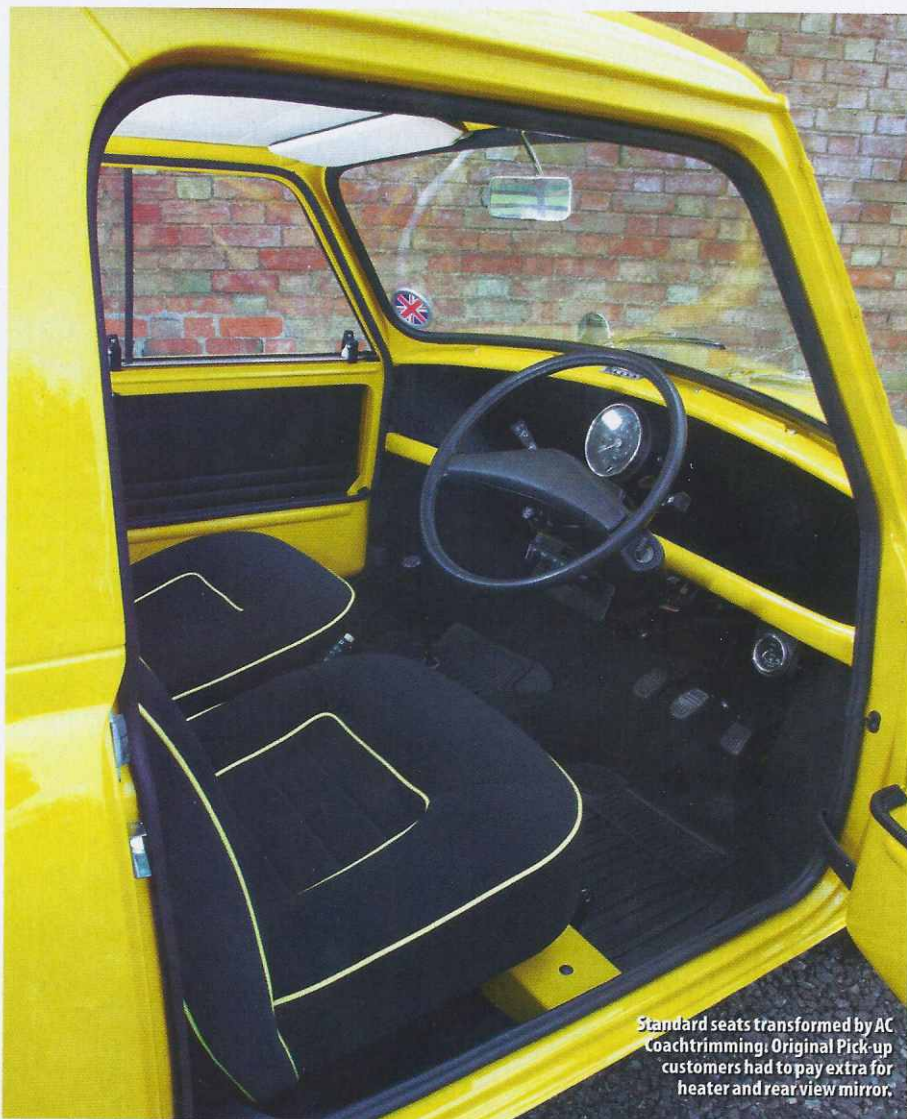
Standard seats transformed by AC Coachtrimming. Original Pick-up customers had to pay extra for heater and rear view mirror.

help refurbish the original seats and re-cover them with non-standard black brushed nylon and yellow piping. The headlining frame had been cut to accommodate the sunroof so they remade the steel strips to achieve a complete new headlining. Instead of going for the optional Pick-up canvas tilt frame and cover, he got AC to make a fabric cover for the loadbay, with Lift-the-Dot and Tenax fasteners. BMC/BL never offered a

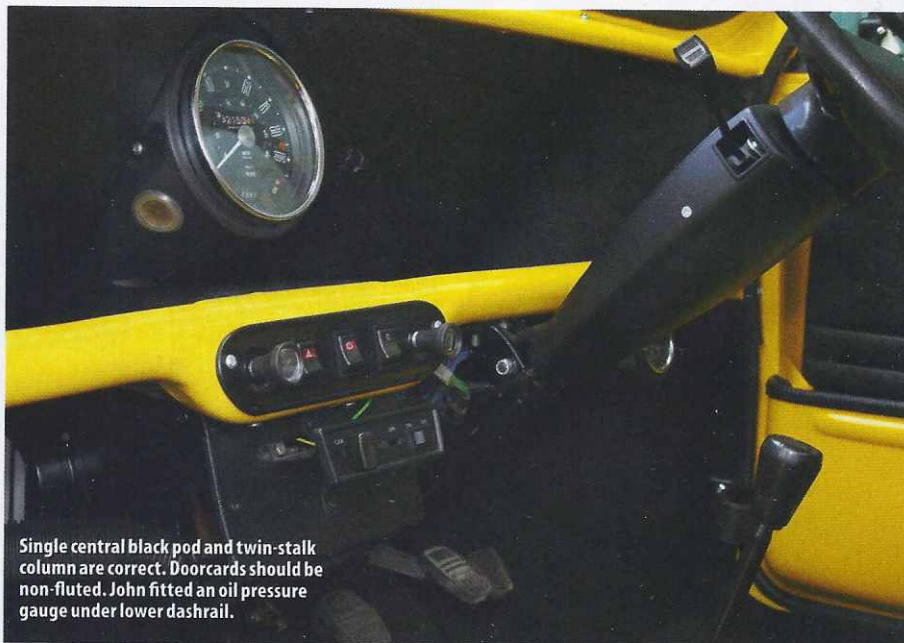
Single central black pod and twin-stalk column are correct. Doorcards should be non-fluted. John fitted an oil pressure gauge under lower dashrail.

Elsewhere in the colour-coded interior there are slight variations from standard. The doorcards are the semi-fluted type, whereas Pick-up would normally have had a plain doorcard. Extra interior door handles were added and an auxiliary oil pressure gauge has been fitted under the offside lower dashrail. Standard Pick-ups were supplied without rear view mirror or recirculatory heater »

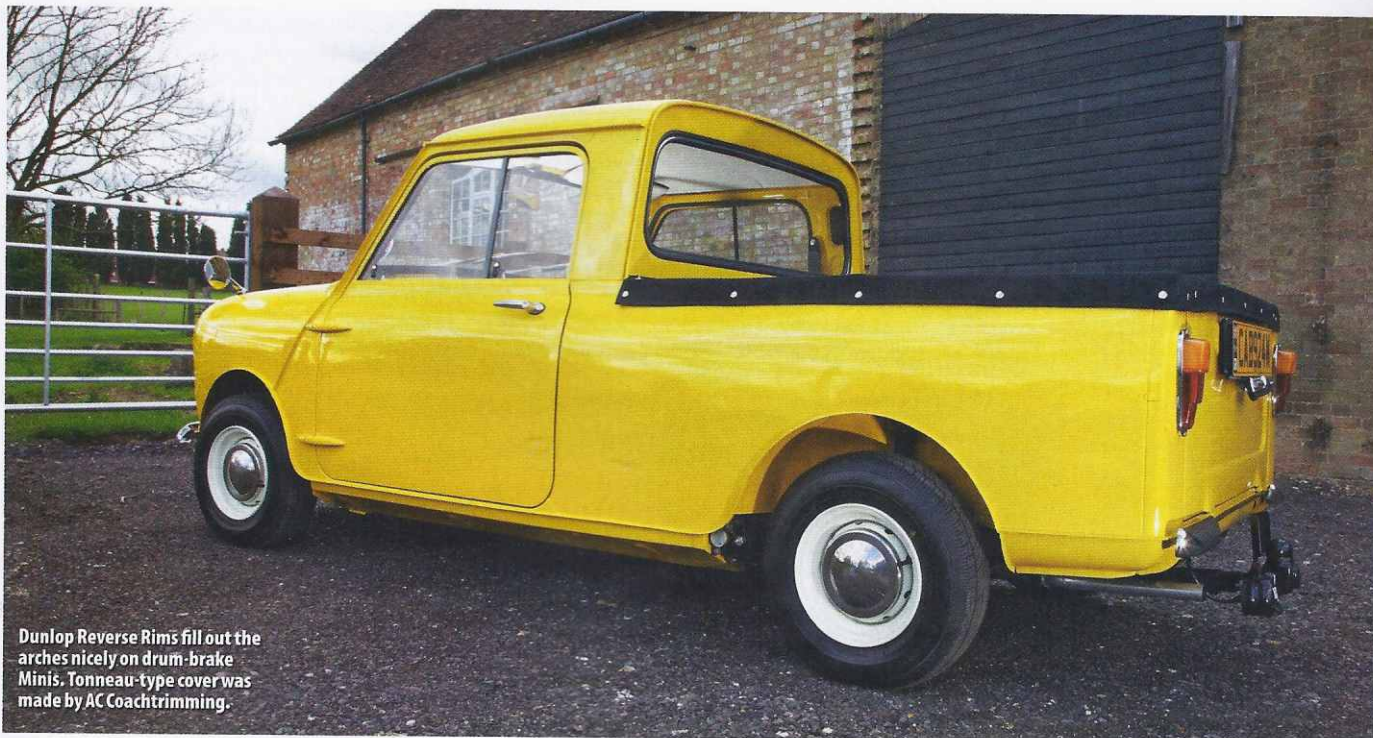
Dunlop Reverse Rims fill out the arches nicely on drum-brake Minis. Tonneau-type cover was made by AC Coachtrimming.

In the pristine engine bay there is an aftermarket alloy rocker box with custom nuts and out the back there's a custom tow hitch. The rear quarter bumpers are correct for a later Pick-up although the rare 'stepped' type Rover P4 rear lights were replaced in 1978 by the larger Lucas 'trailer' type assemblies. Perhaps the most visible departure from standard is the fitment of Dunlop reverse rim 4.5x10 ventilated

steel wheels. These have the correct Van/S type wheel trims but the Pick-up was always fitted with standard 3.5x10 non-ventilated Mini/Cooper steel wheels. Outer sills for a Pick-up would have been the six-flute type from 1971.

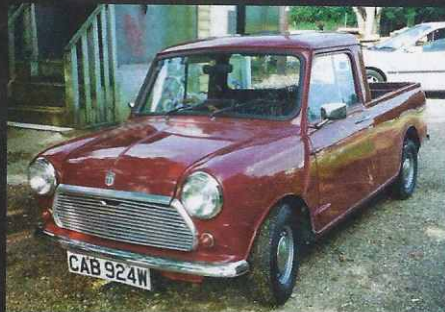
"Shell was sandblasted by ourselves, which was a real bonus, but did it unearth some bloody big holes. Most of the old repairs had been stuck on and filled over."

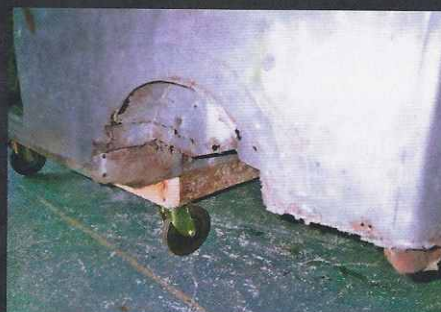
After blasting: "Once blasted, make sure you prime the whole vehicle as it started to rust and we had to have it blasted again."

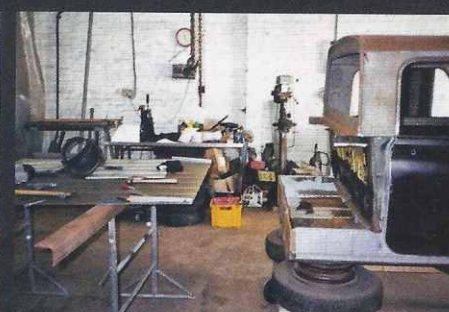
The body shop had to resort to some pretty drastic cutting and cleaning before a long list of new panels could be assembled.

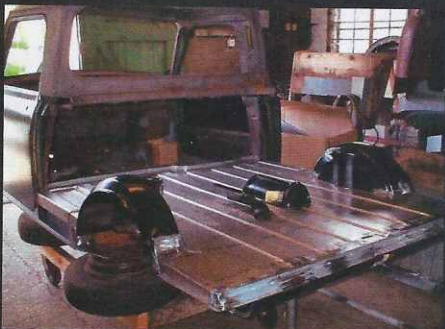
New rear floor and arches in place before rear bulkhead was welded in. Precise panel alignment is the big challenge here.

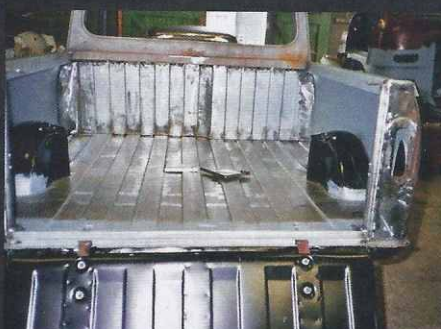
New body sides and tailgate in place. Swaged shape of floor and bulkhead present some real difficulties for the restorer.

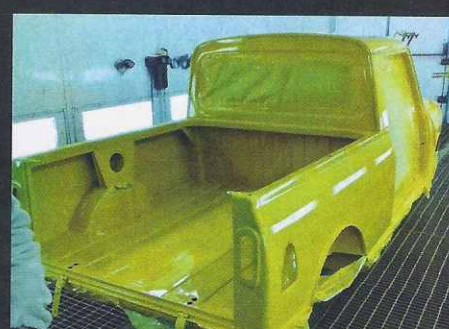
"The Inca Yellow was chosen because, when we sandblasted it back through the layers (which looked like a stick of rock) the very last colour was yellow."

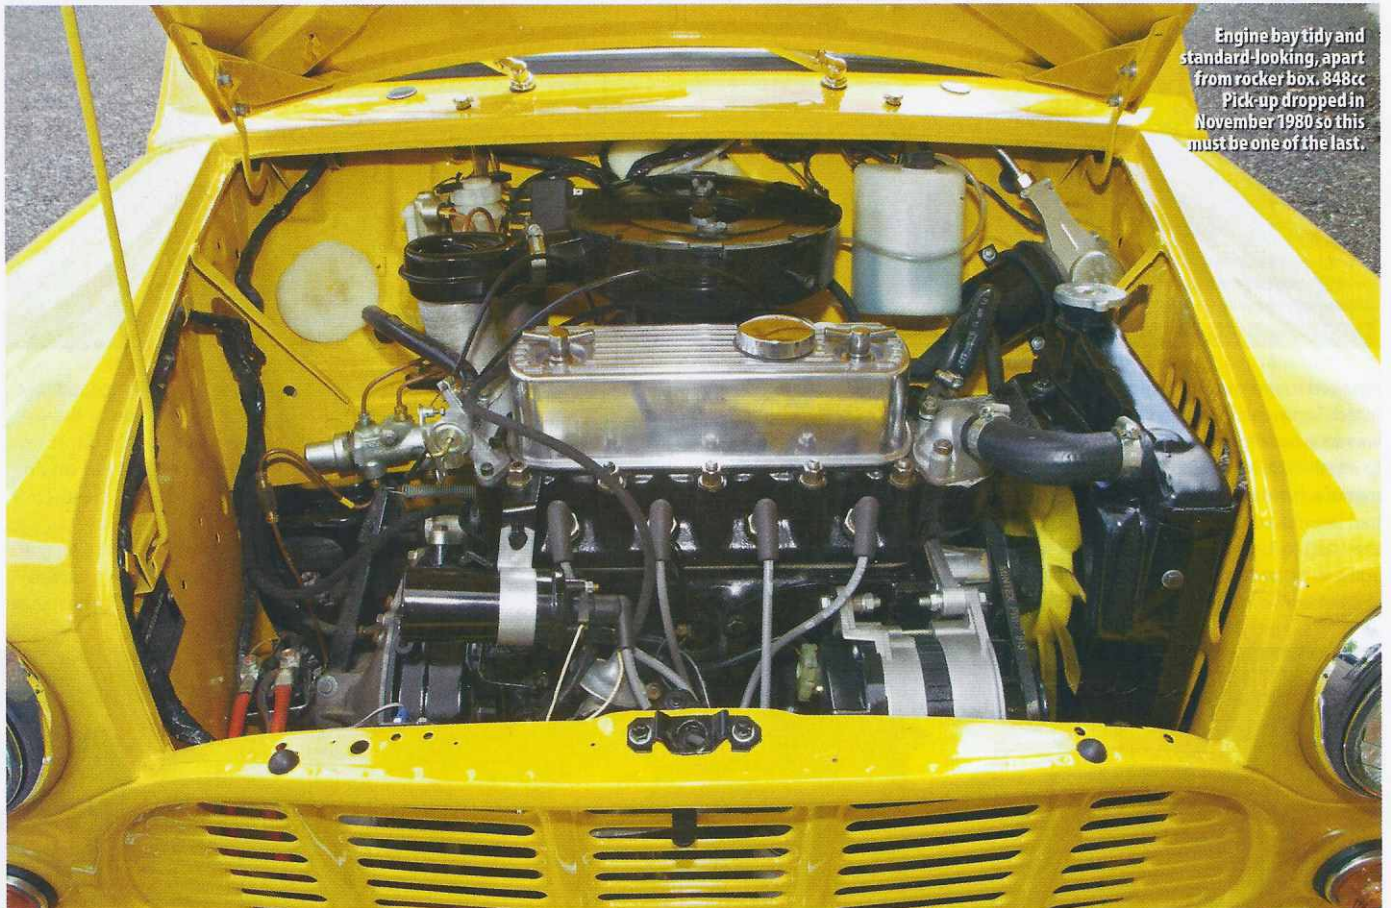
Engine bay tidy and standard-looking, apart from rocker box. 848cc Pick-up dropped in November 1980 so this must be one of the last.

Once the reworked engine had been refitted with a standard exhaust system and single SU HS4 carburettor, it was time to get it up and running for a test. "The engine rebuild was fairly straightforward until the run-up and testing, when it blew a core plug behind the alternator. The thermostat was removed and tested and found to be faulty, even though

it was a brand new one. We replaced the thermostat, testing it before fitting, and ran up the engine only to find, to our disappointment, that it had blown the head gasket as well.”

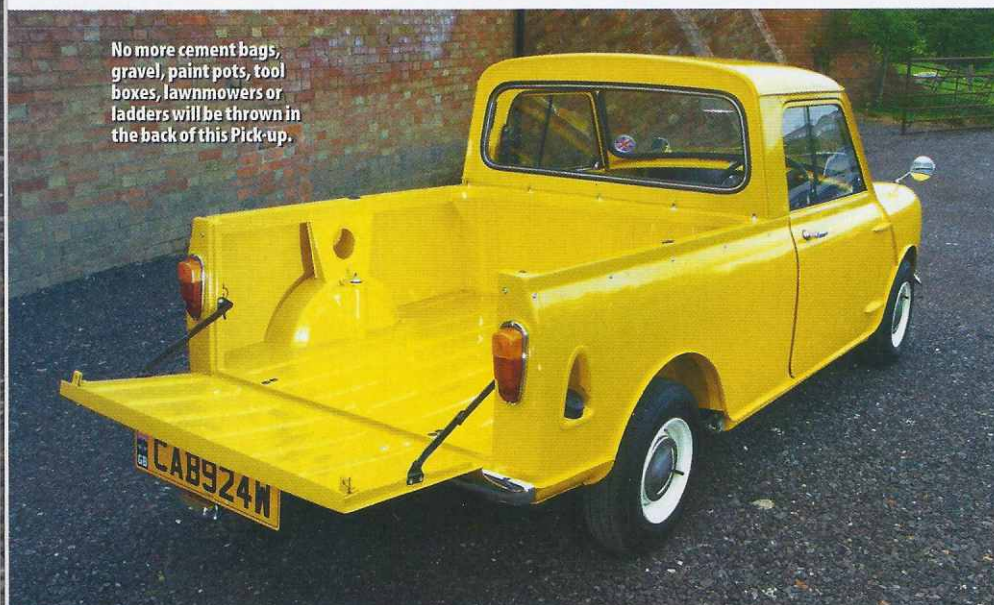
No more cement bags, gravel, paint pots, tool boxes, lawnmowers or ladders will be thrown in the back of this Pick-up.

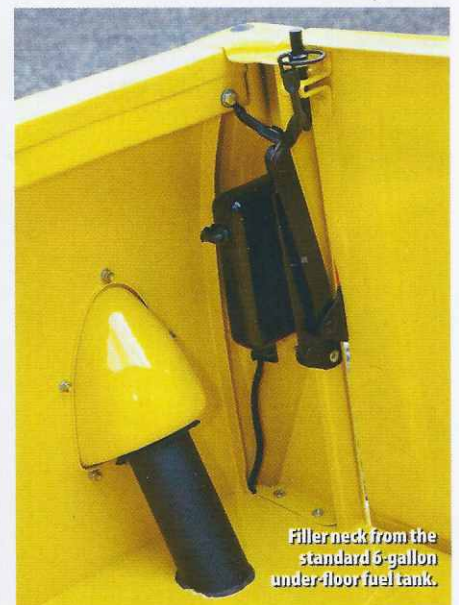
Filler neck from the standard 6-gallon under-floor fuel tank.

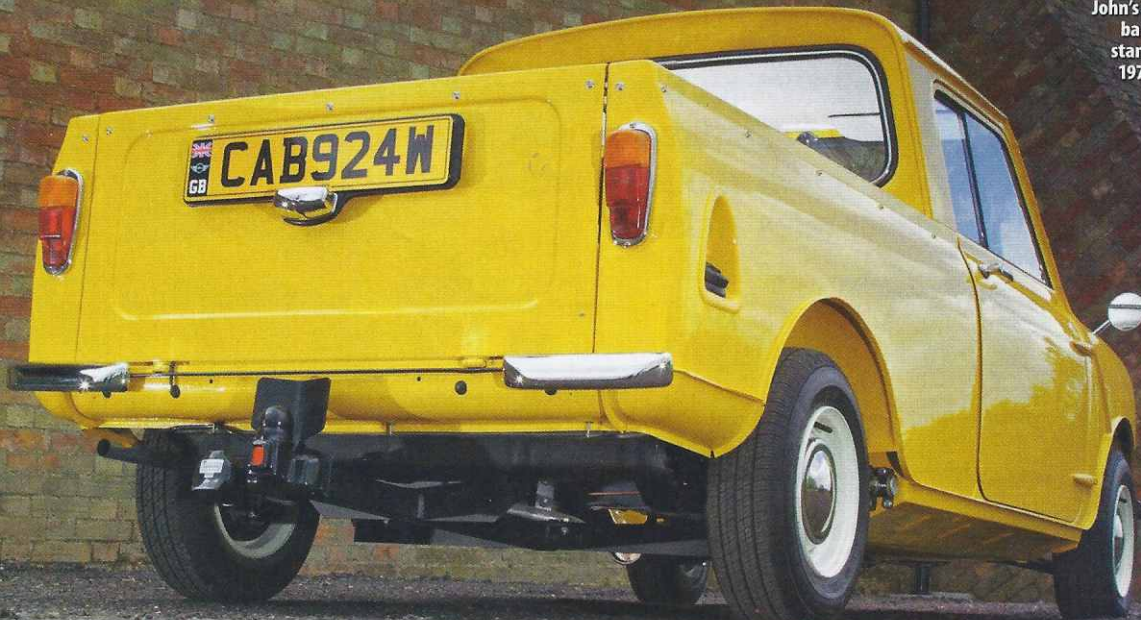
Spotless in all the right places! John's son, Darren, made the tow bar. Rover P4 rear lights were standard for Mini Pick-up until 1978, then replaced by bigger Lucas trailer-type unit.
